REPORT NO: NAWCADPAX/TR-2000/59

BREAKDOWN OF PRESERVATIVE FLUID MIL-PRF-46170 IN AIRCRAFT HYDRAULIC SYSTEMS

29 March 2001

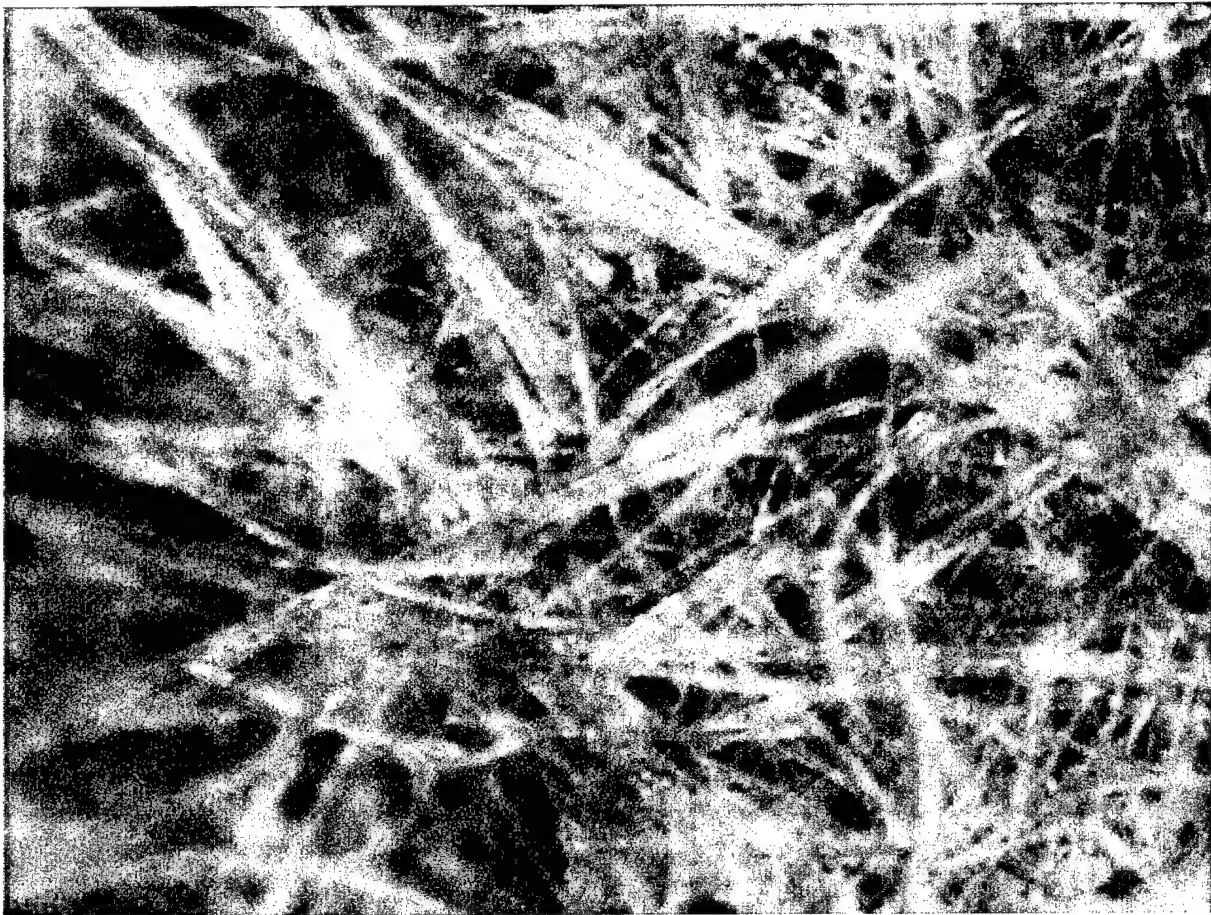
Figure 1: Test Stand Filter Element After 22 hr

Return fluid temperature was maintained at 215°F and filter pressure differential was measured at the end of each day of testing. Aircraft representative fluid chemistry caused steady long-term buildup of material in system filter (figure 1). Similar to aircraft filters, test stand filters were plugged with organic material collecting in 22 hr. This relatively long-term continuous buildup was evaluated in phase 2 testing.

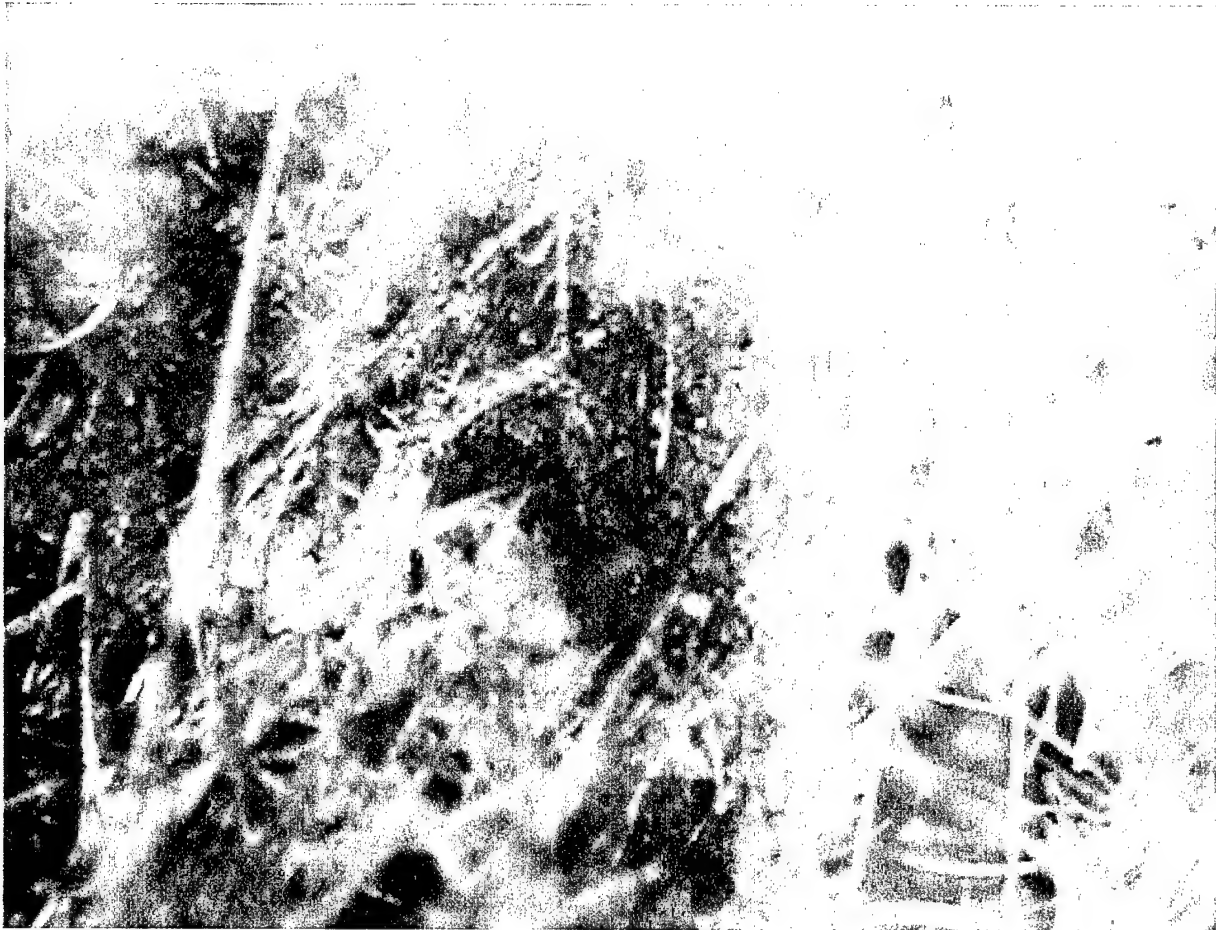
Figure 4: Test Stand Filter Element (48 hr)

System baseline testing had progressed to 45 hr with minimal filter loading when an abrupt increase in pressure was observed. Inspection of the system identified a rupture in the heat exchanger that was adding large amounts of water to system fluid.

Inspection of filter media showed that material was present in large chunks against relatively clean media fibers (figure 4). The ruptured heat exchanger allowed water (a polar solvent) to enter the system and release large chunks of material that had formed in the system during previous testing or was an agent causing extremely rapid fluid breakdown under these conditions.

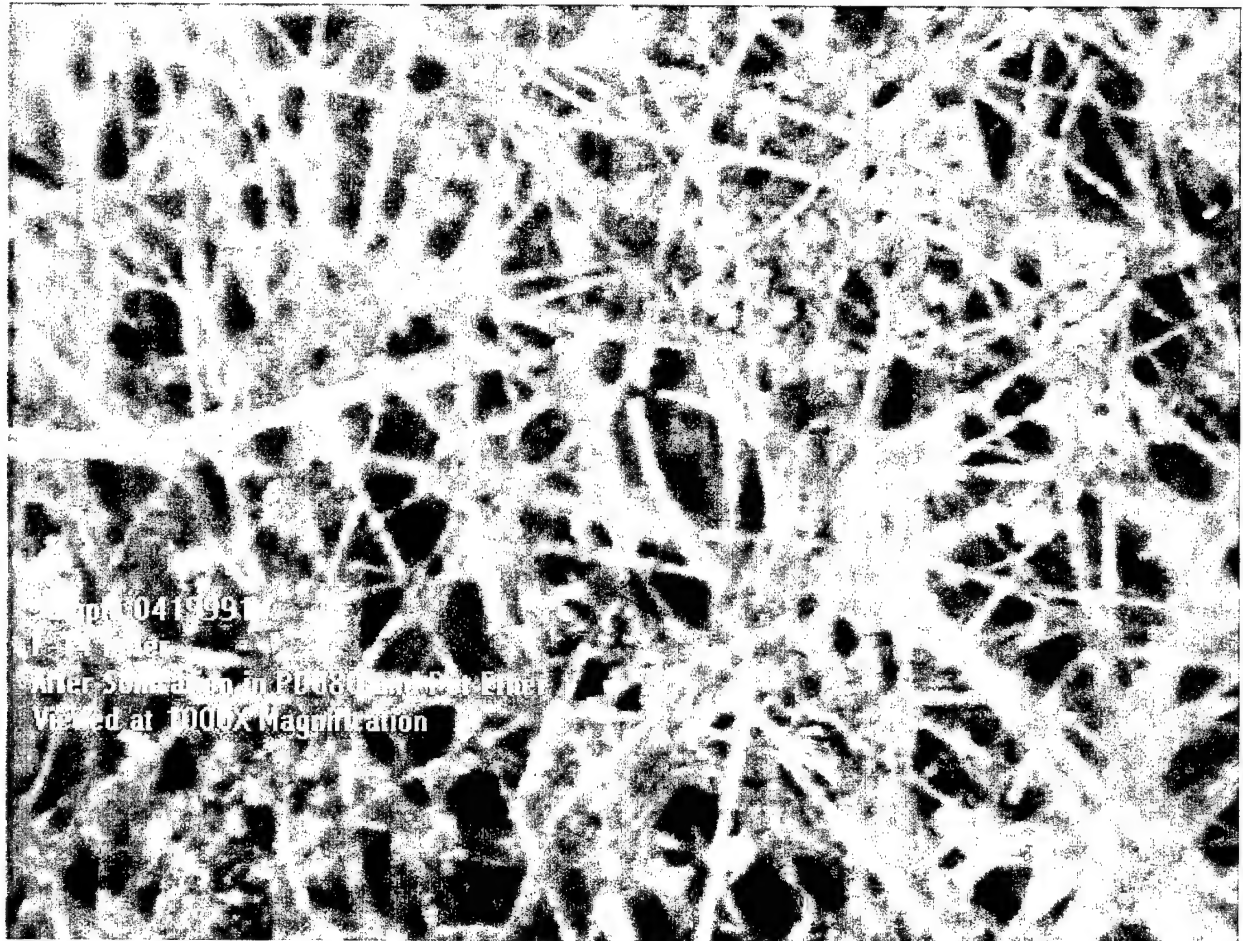
Figure A-1: F-14 Filter Element After Wash

Filter elements for F-14 hydraulic systems are replaced at each 300 hr phase inspection. Filters are also changed between phases if filter delta P buttons indicate excessive pressure drop. Filter elements for Navy aircraft trap particles 5 micron and larger in size. Inspection of a prematurely clogged filter element (shown in figure A-1) revealed large amounts of red organic material collecting within the filter media.

The filter element was ultrasonically washed in PD-680 to remove hydraulic fluid and material mechanically trapped within the filter. While many of the larger passages are open, the smaller fluid passages through the media are blocked with an insoluble organic gel, causing a significant reduction in flow area and increased pressure drop. The filter plaque is red in color with a transparent gelatinous appearance. A polar solvent toluene/xylene is required to dissolve the filter plaque.

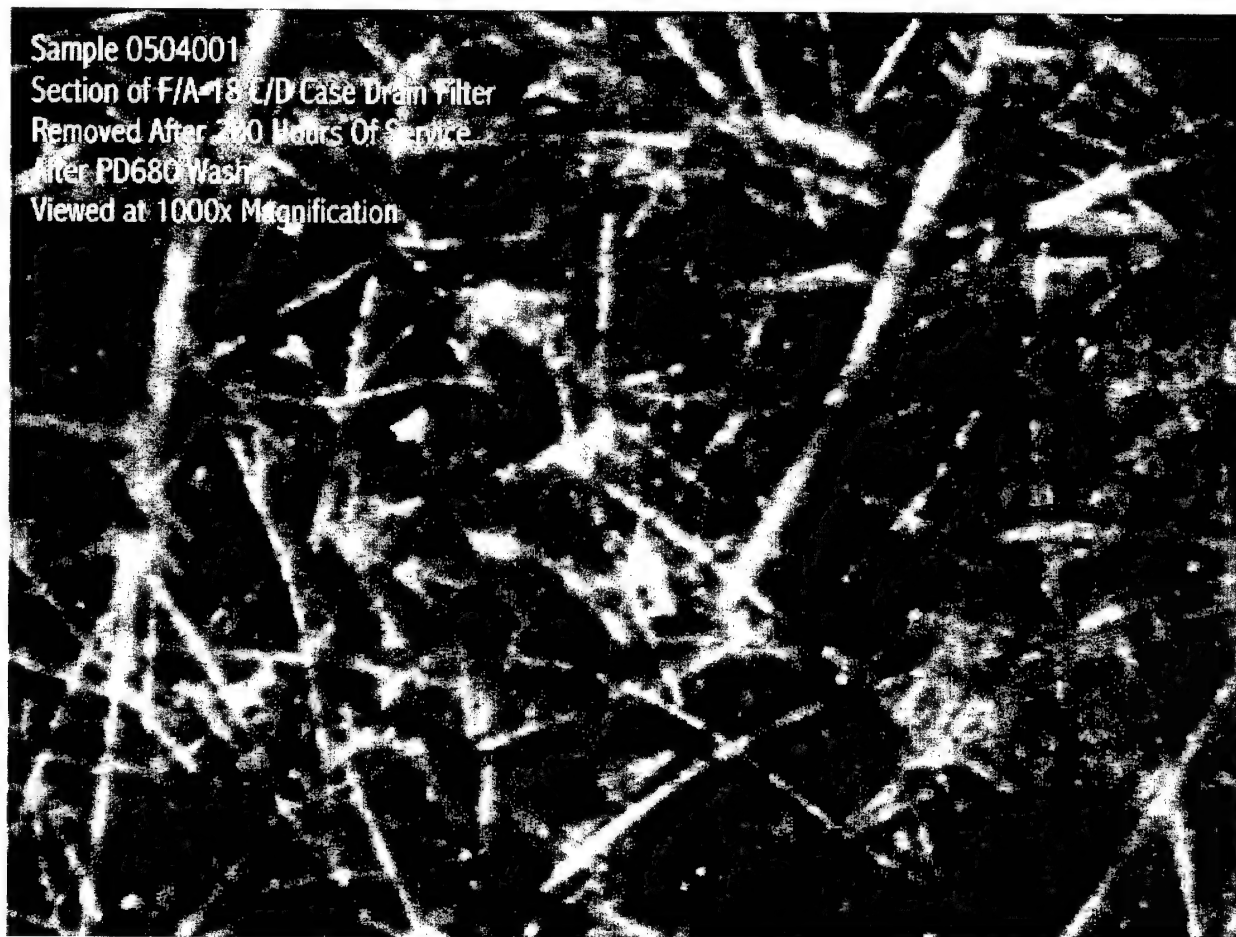
Figure A-2: F/A-18C/D Filter Removed After 200 hr

A 200 hr case drain filter was ultrasonically washed with PD-680 to remove any material mechanically lodged in filter fibers. The cleaned filter (figure A-2) shows large amounts of dark organic gel still clogging most of the fluid passages through the media.

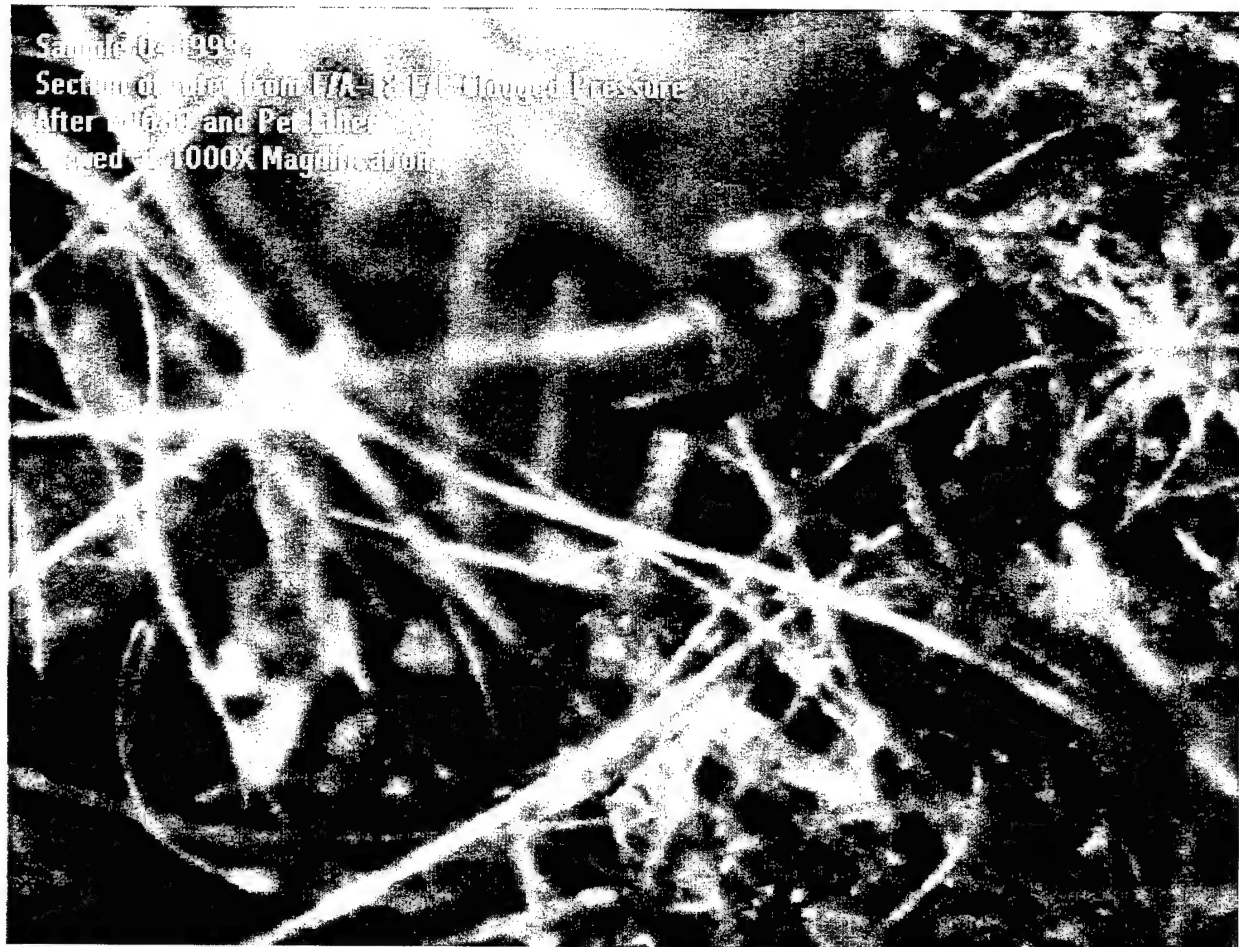
Figure A-3: F/A-18E/F Clogged Filter After Wash

Shortly after introduction of the larger pump, filters started to fail at 70 hr. Filters continued to clog at ever increasing rates until some filters were clogged at 20 flight-hours. Problems with filter clogging were worse on HS-1 vice HS-2 due to higher fluid temperatures. The case drain filter element clogging was most severe due to high fluid temperatures and small filter elements.

During this same time period, the leading edge flap HDU motors started to experience premature wearout. Each new motor failed earlier and earlier in service. The wear rate on HS-1 motors was twice that of wear on HS-2 motors. Analysis of clogged filters identified most of the material as an insoluble organic gel (shown in figure A-3). While the HDU motors were wearing out at a rapid rate, the amount of bronze material in the typical clogged filter was minimal.

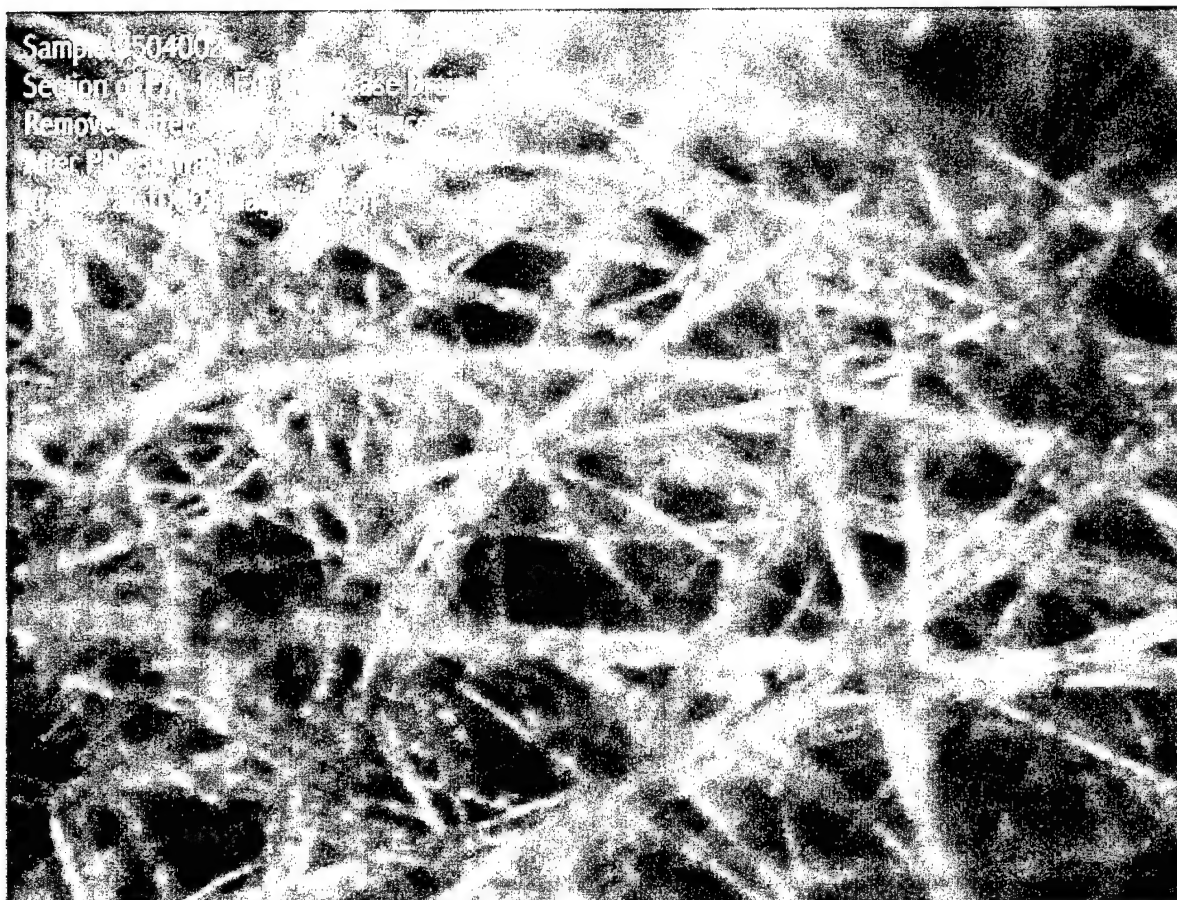
Figure A-4: F/A-18E/F Case Drain Filter With Improved HDU Motor

Inspection of filter elements removed after 59 hr of service (figure A-4) show buildup of an insoluble red organic material similar to F-14 system filters. Most fluid passages are open and filter service life has improved dramatically. The plaque buildup rate has been significantly reduced but fluid breakdown is still occurring.

Note: All filter elements inspected prior to the HDU motor redesign had dark green organic material, while current filter elements show buildup of red organic material, similar to material collecting on F-14 hydraulic system filters.

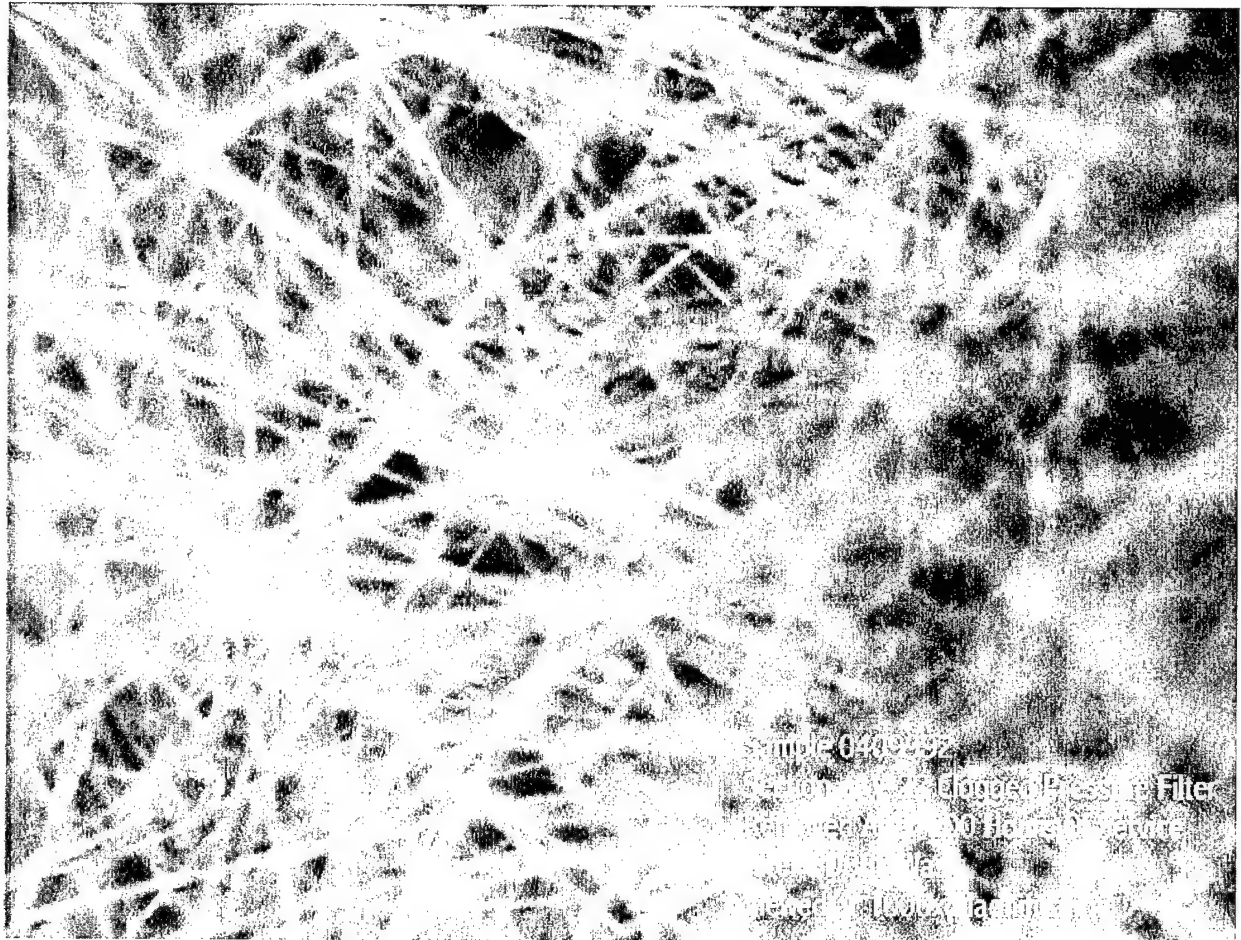
Figure A-5: V-22 Clogged Filter After Wash

elements are still in service with well over 400 flight-hours. The filter was checked to verify excessive pressure drop and identify filter debris. Most of the material was wear debris and system contaminants.

Washing the media with PD-680 removed the bulk of the material, resulting in clean light gray fibers (figure A-5). Fibers were straight and uniform with no evidence of filter plaque.

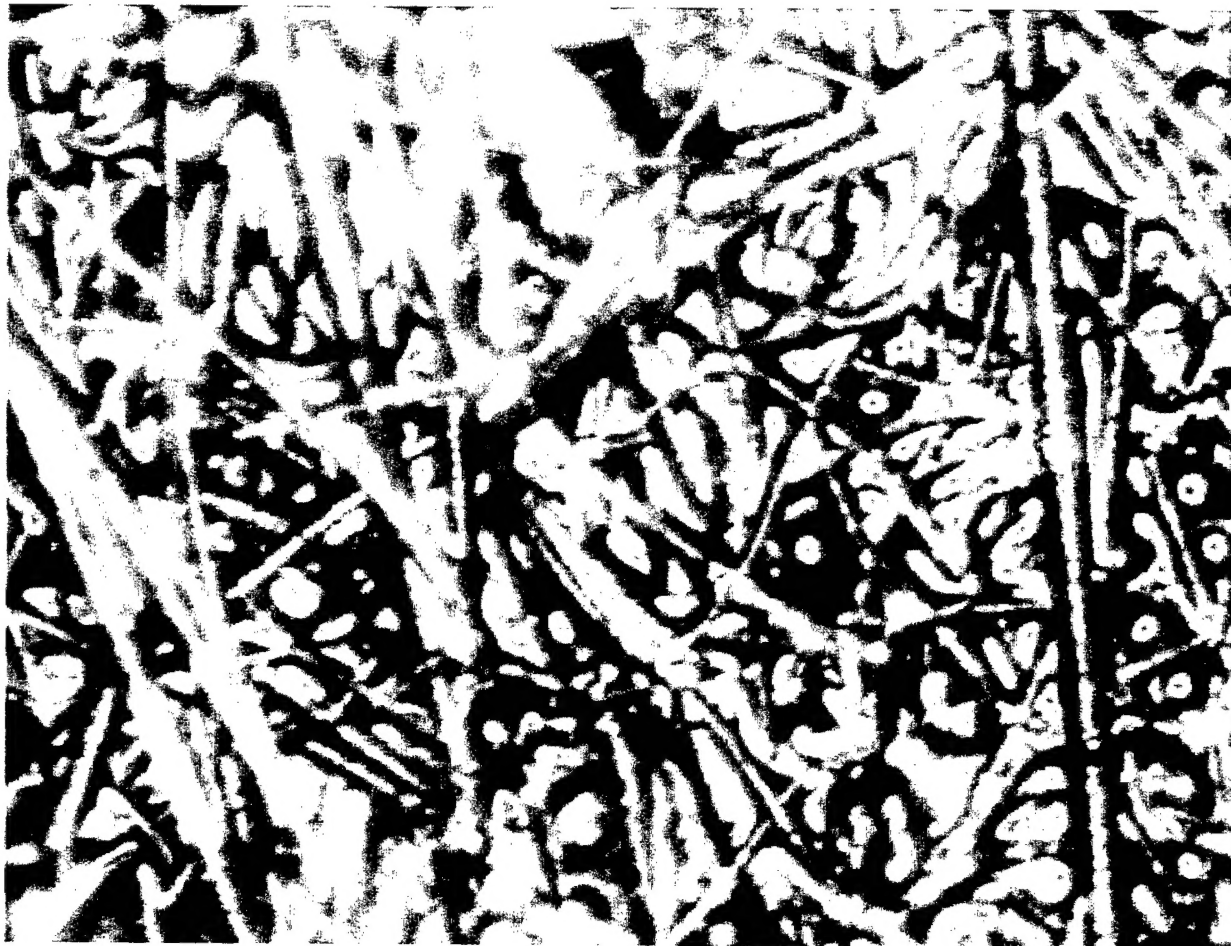
Figure A-6: S-3 Aircraft Generator CSD Clogged Filter After Wash

Filter elements from CSD units for generators from EA-6 and S-3 aircraft (figure A-6) show insoluble green organic material very similar to the material formed in Boeing 777 generator integrated drive units. It is reasonable to suspect that, as with Boeing 777 generators, this mechanism is leading to premature in-service failures of generator drive units.

There are several sources and types of MIL-PRF-23699 fluids available, if premature service life is a problem, an alternate vendor (with a different additive package) or selection of a severe duty version of MIL-PRF-23699 may help improve reliability. Any equipment using MIL-PRF-23699 may potentially suffer from this mechanism. Further investigation of this type is beyond the scope of this effort.
